# Manhole Inspection Summary

Manhole # S33GG\_038MH

**Location** Address: **MT ROYAL AVE** Cross Street: **MARYLAND AVE**

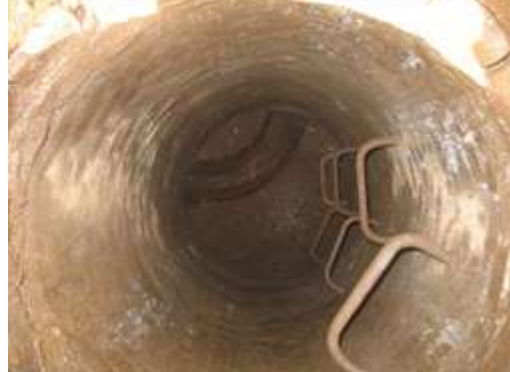
Top View

Corroded steps. Bench debris.

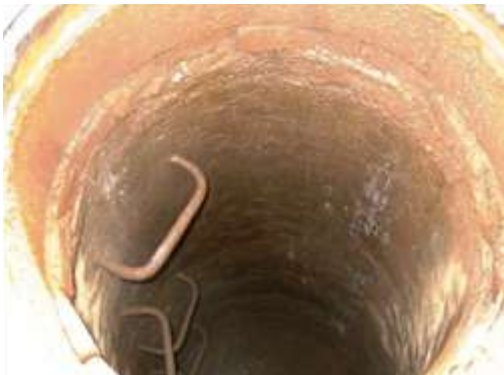
Defect

Frame leaks. Adjustment deterioration and infiltration. Barrel infiltration.

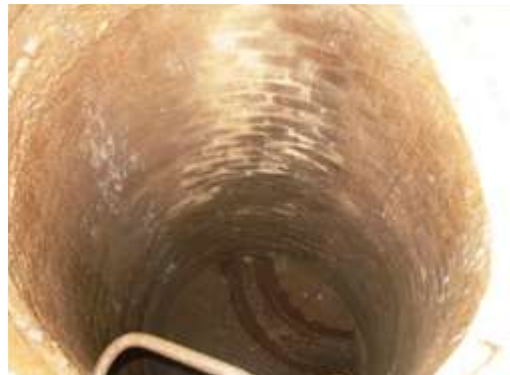
Defect

Frame leaks. Adjustment and Barrel infiltration.

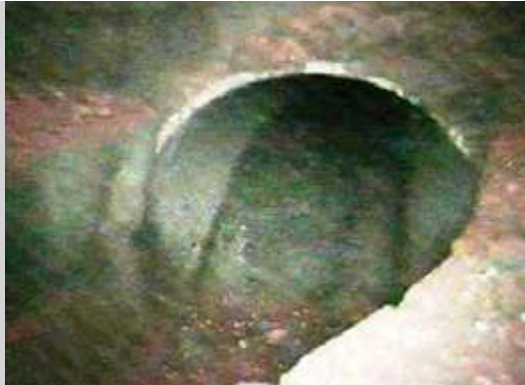
### 8 in. Circular Gravity Sewer Pipe Out @ 12 O'Clock

Deposits: ☒ None ☐ Mud ☐ Sludge ☐ Debris ☐ Grease

Infiltration: **None** Pipe Seal Cond: **Unknown**

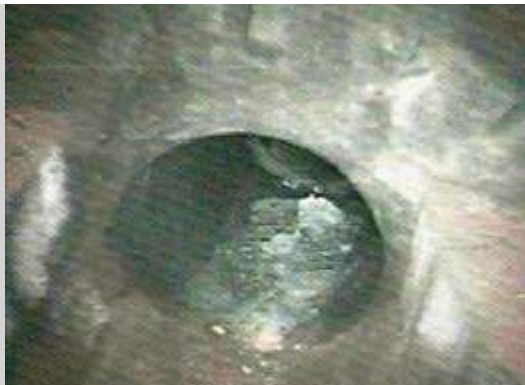
### 8 in. Circular Gravity Sewer Pipe In @ 9 O'Clock

Deposits: ☐ None ☐ Mud ☐ Sludge ☒ Debris ☒ Grease

Silt Depth: **0.5** (in.) Deposits Extent: **Light**
